Manhole Inspection Summary

Manhole # S25EE_045MH

Insp Date: **10/23/07 9:00 AM**

Location Address: **1705 BRUNT ST**

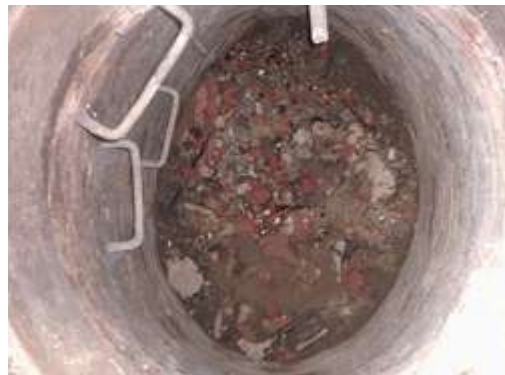
Top View

Channel debris.

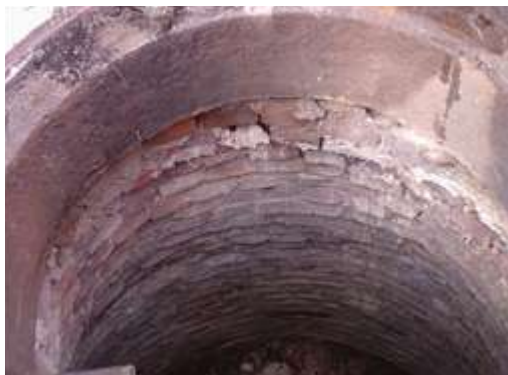
Defect

Frame leaks. Adjustment deterioration, loose brick and infiltration. Corbel and Barrel infiltration - other side.

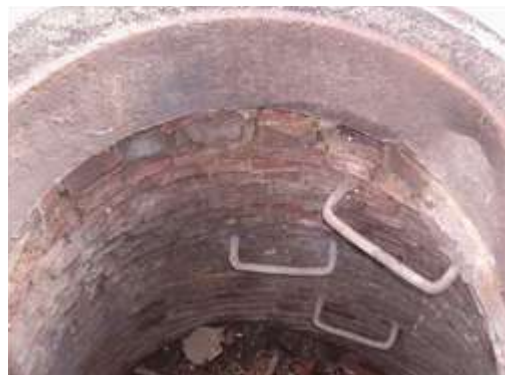
Defect

Frame leaks. Adjustment deterioration and infiltration. Corbel and Barrel infiltration.

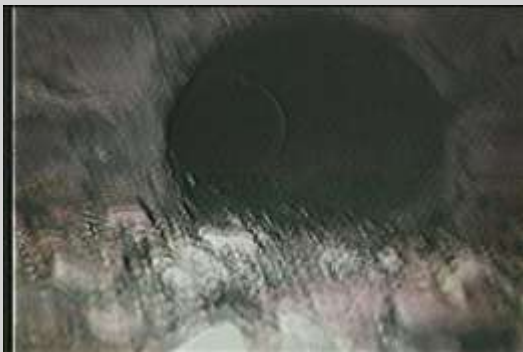
8 in. Circular Gravity Sewer
Pipe Out @ 12 O'Clock

Deposits: ☐ None ☒ **Mud** ☐ Sludge ☒ **Debris** ☐ Grease

Silt Depth: **1** (in.) Deposits Extent: **Light**

Infiltration: **Evidence** Pipe Seal Cond: **Cracked**
